MERRIMACK RIVER BASIN  
DUNSTABLE, MASSACHUSETTS

MASSAPOAG POND DAM  
MA 00136

PHASE I INSPECTION REPORT  
NATIONAL DAM INSPECTION PROGRAM

NOVEMBER 1978

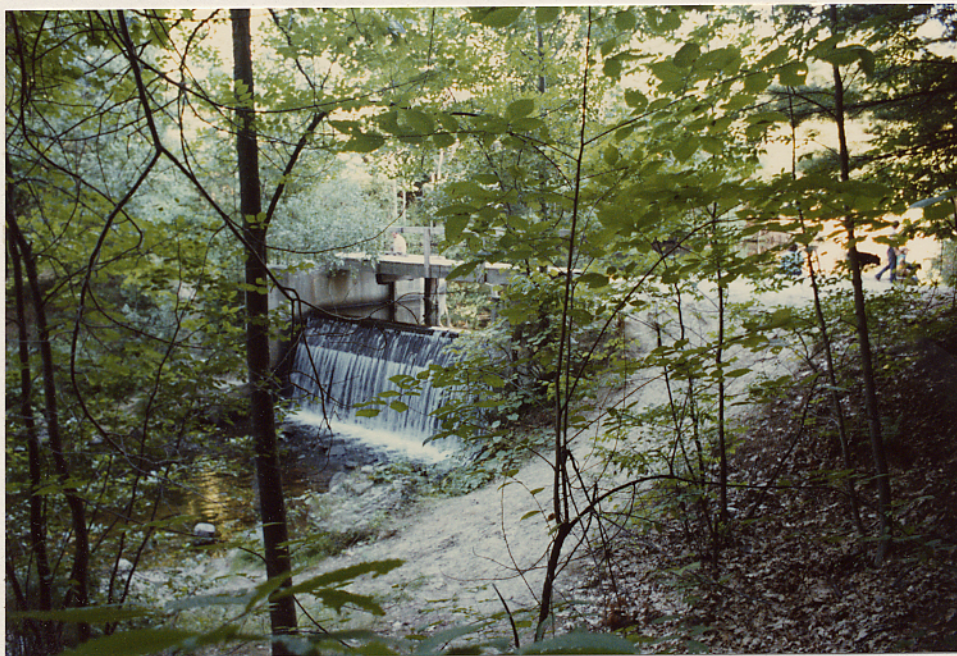
1. OVERVIEW OF DAM FROM LEFT DOWNSTREAM EMBANKMENT. NOTE EROSION CAUSED BY FOOT TRAFFIC AT DAM LEFT ABUTMENT.

3. Provide erosion protection where it is lacking or deficient on the upstream face of the dam, and repair locations where the dam cross section has been reduced due to foot traffic or water action.

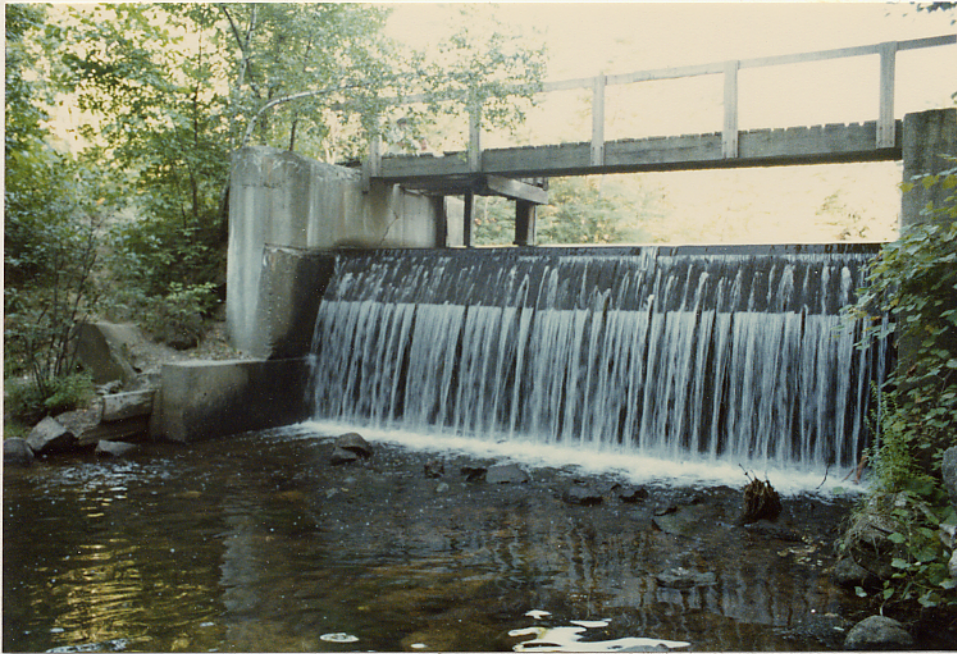
- b. Dam - The concrete portions of the dam (the sidewalls of the spillway) were found to have local spalls, some efflorescence, minor vertical cracking, and local deterioration as shown in Photo Nos. 2, 4 and 5. Steel bars are present in the exterior surface of the left upstream wall. Deteriorated timbers are present just downstream of the weir in the left concrete wall as shown in Photo No. 6. A void is present on the rear face of the right sidewall at the downstream end as shown in Photo No. 7.

2. VIEW OF DOWNSTREAM FACE OF DAM.

4. Replace the deteriorated members in the operating platform and footbridge.
5. Paint all exposed timber members to minimize future deterioration.
6. Remove all minor vegetation from concrete surfaces and remove all deteriorated concrete. Local spalled and eroded areas should be patched.

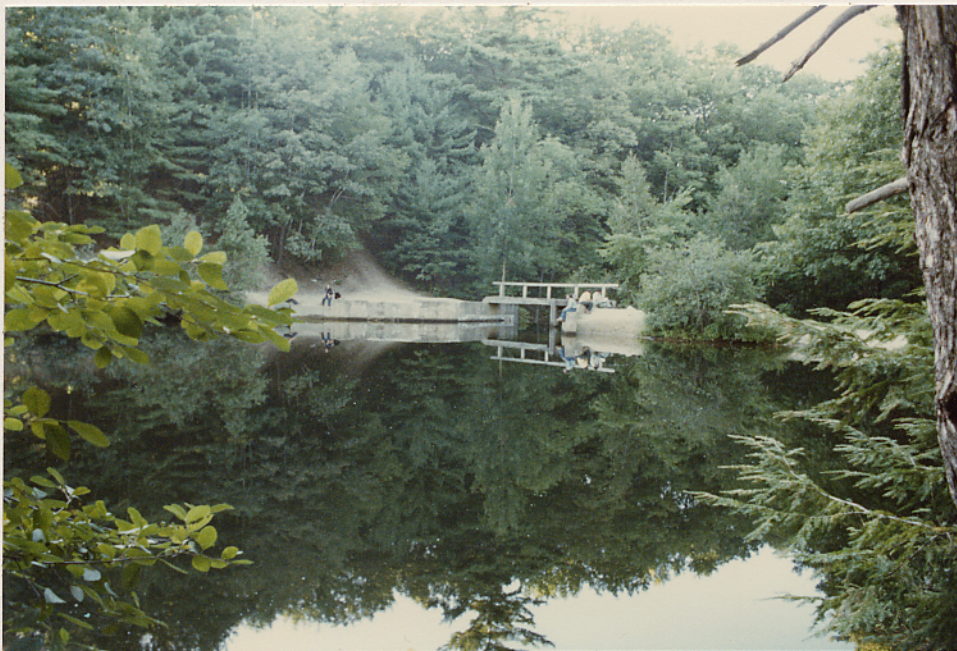
3. VIEW OF DAM FROM UPSTREAM RIGHT EMBANKMENT.

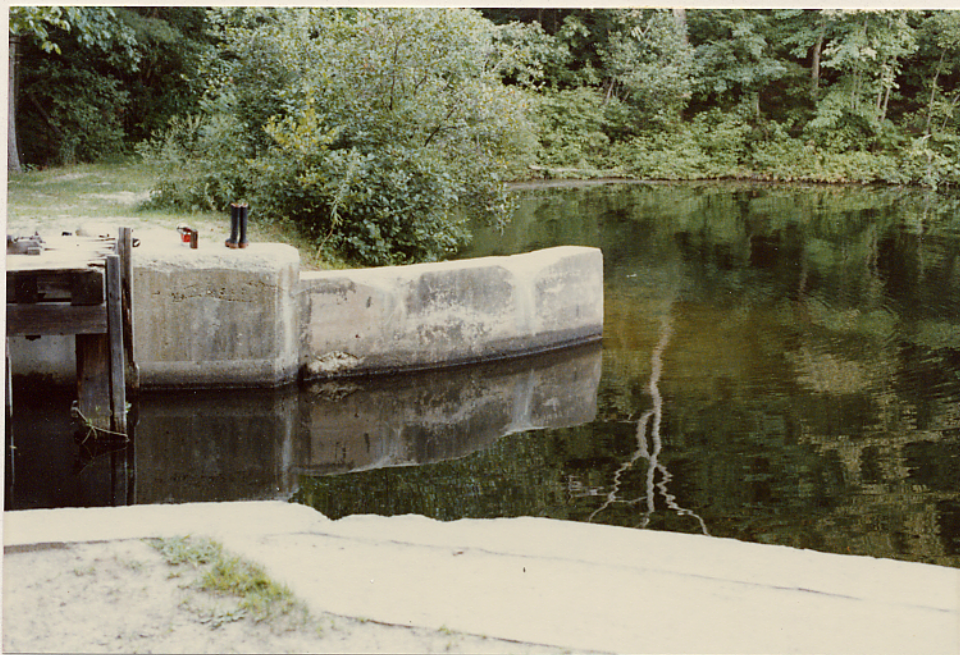
4. APPROACH CHANNEL RIGHT TRAINING WALL.

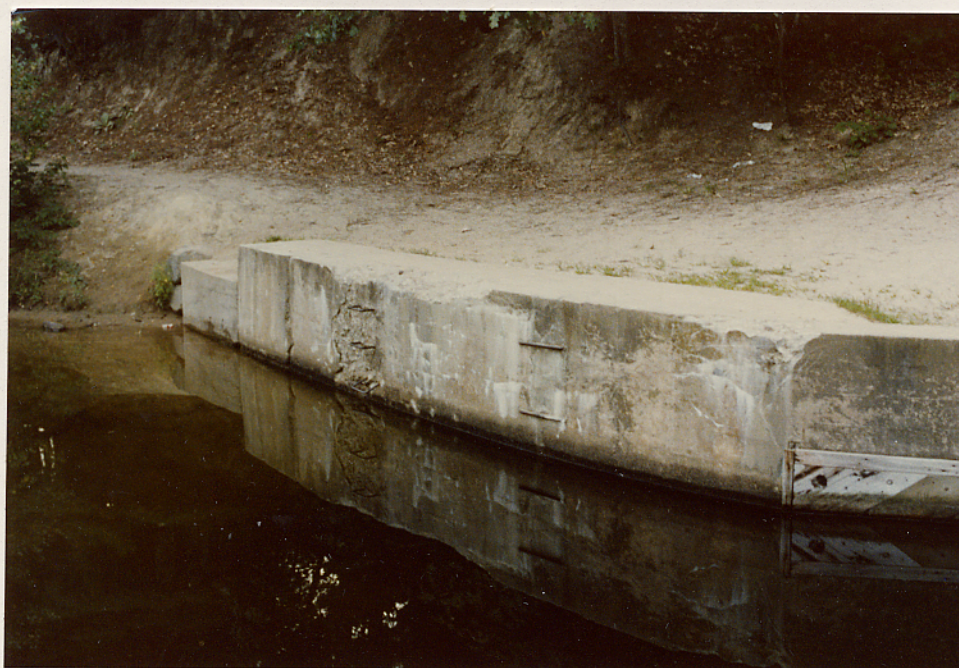
5. APPROACH CHANNEL LEFT TRAINING WALL.

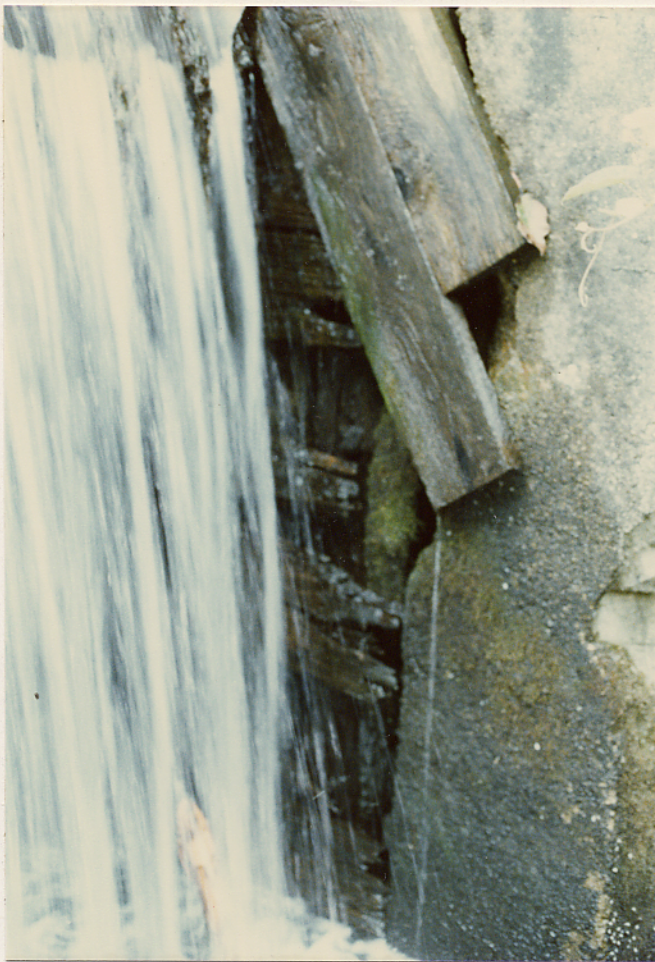
The timber weir was observed to be in good to fair condition. A portion of the downstream face of the timber weir was observed by going beneath the falls. The area observed was that portion immediately adjacent to the timber gate. The timber was found to be waterlogged and some members were found to be easily penetrated to a 3/4 inch depth with a geologist pick. As indicated above, timber adjacent to the left sidewall is deteriorated. This timber does not currently serve as a support for the weir.

6. DETERIORATED TIMBERS AT LEFT SIDE OF SPILLWAY DOWNSTREAM OF CREST.

7. Remove the deteriorated timbers from the left sidewall just below the timber weir and replace the removed timbers with concrete.

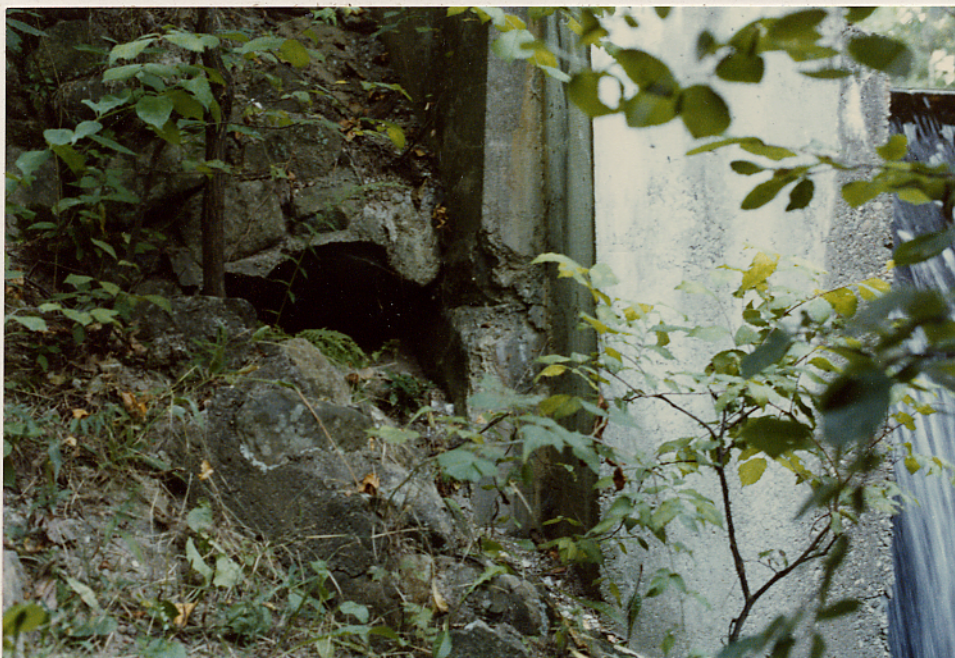
- (1) The lower part of the relatively steep downstream slope behind the right spillway wall appears to have been previously repaired by patching with concrete and rock fragments. The dam crest width is also reduced above this location. As shown in Photo No. 7, there is a hole

7. MISSING STONE IN DOWNSTREAM RIGHT SIDE WALL OF SPILLWAY.

1. Repair and restore the downstream embankment slope and the dam crest width behind the right spillway wall by improving erosion protection at the toe, removing loosened or undermined material and vegetation on the slope, and reconstructing the slope to adequate dimensions.

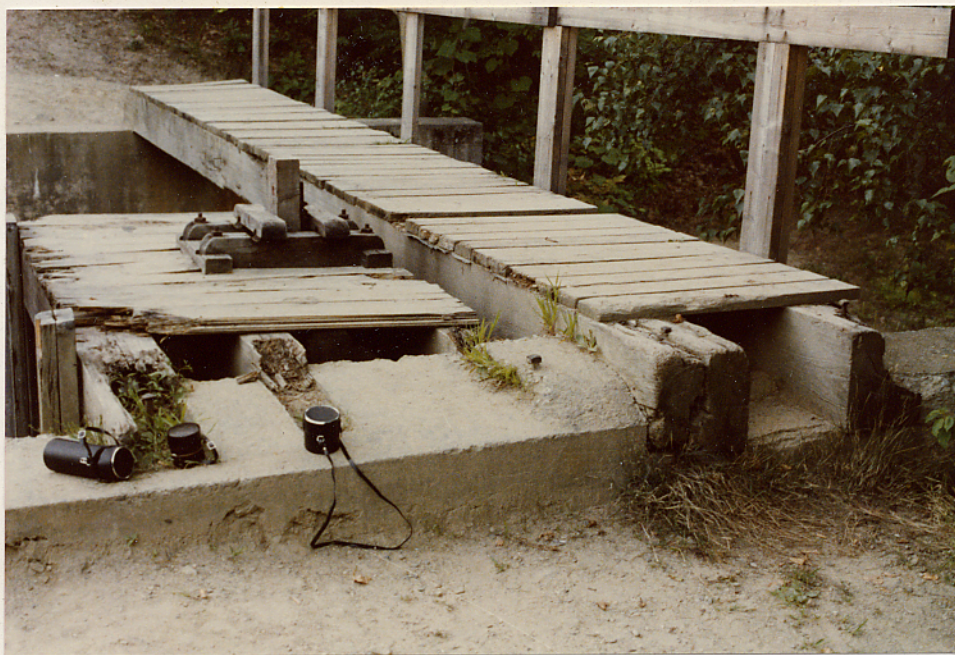
- c. Appurtenant Structures - The operating platform for the reservoir drain is in fair to poor condition. The end of the support beams for the platform have deteriorated as shown in Photo No. 8. The decking has started to deteriorate on the upstream end. The vertical support posts have deteriorated at the normal water surface line. One of the posts appears to have a temporary support scarfed onto it. The downstream face of the gate appears to be waterlogged timbers. The operator for the gate is not present at the spillway. Inspection records indicate that this gate was repaired in 1973. It is believed to be operational and it is estimated that it is operated by a pry bar.

The footbridge over the weir is in fair condition. A few of the deck planks are missing and the ends of the timber stringers have started to deteriorate as shown in Photo Nos. 8 and 9. The foot bridge and the operator platform require replacement of individual members and painting.

8. RESERVOIR DRAIN GATE OPERATOR AND FOOTBRIDGE FROM RIGHT ABUTMENT.

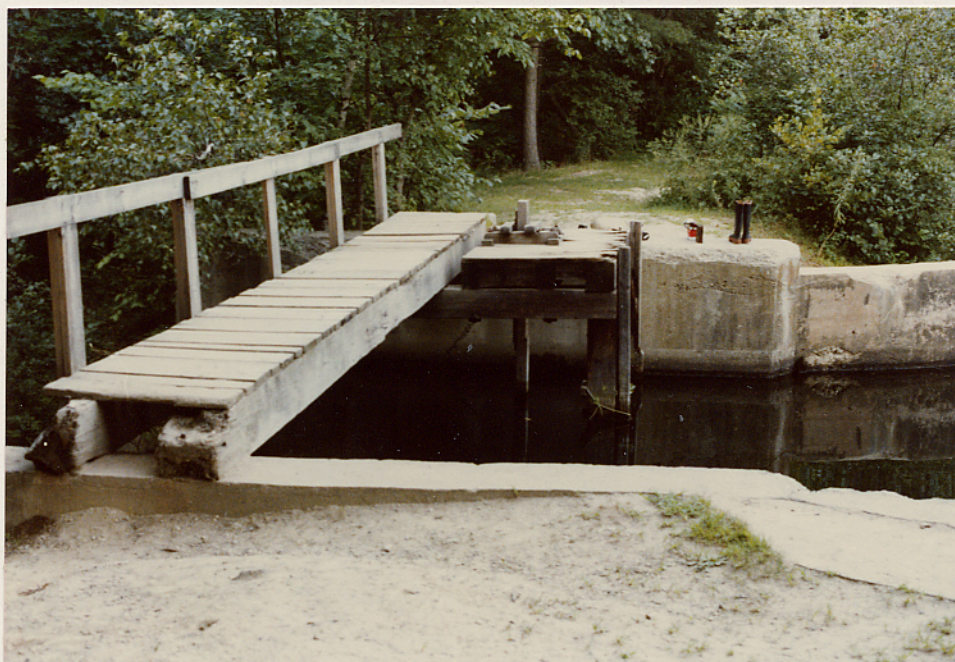
9. RESERVOIR DRAIN GATE OPERATOR AND FOOTBRIDGE FROM LEFT ABUTMENT.
